## A Complex Fishing Application Yields Success in Ecuador

Experienced Wellbore Integrity Solutions (WIS) personnel planned and recovered a heavily corroded completion, allowing the restoration of well production in the Sucumbios region of Ecuador.

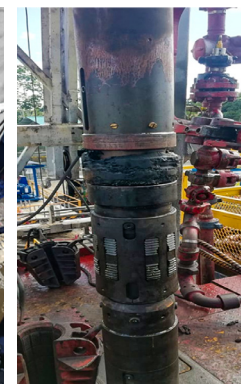
Figure 4: Successful recovery of lower Quantum Packer.
