Successful Execution of a Challenging Dual Completion Fishing Operation in the UAE

Experienced Wellbore Integrity Solutions (WIS) personnel planned and recovered a severely corroded dual completion.

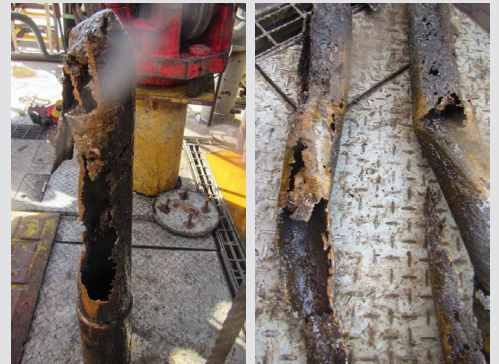
Figure 1: Recovered corroded tubing.

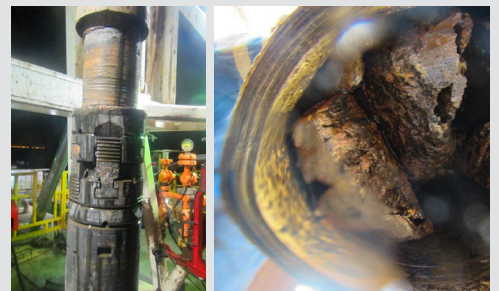
Figure 2:
Recovered HS
packer.

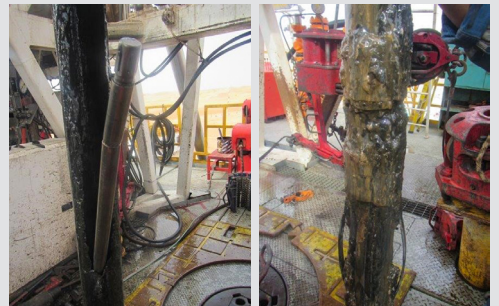
Figure 3: Corroded tubing
junk recovered.
