## Responsive Service and Flawless Execution Demonstrated in the Installation of a 9 5/8 inch High-pressure Casing Patch in the North Sea

Wellbore Integrity Solutions was called upon to plan, mobilize, and successfully install a high-pressure casing patch during a work-over operation.

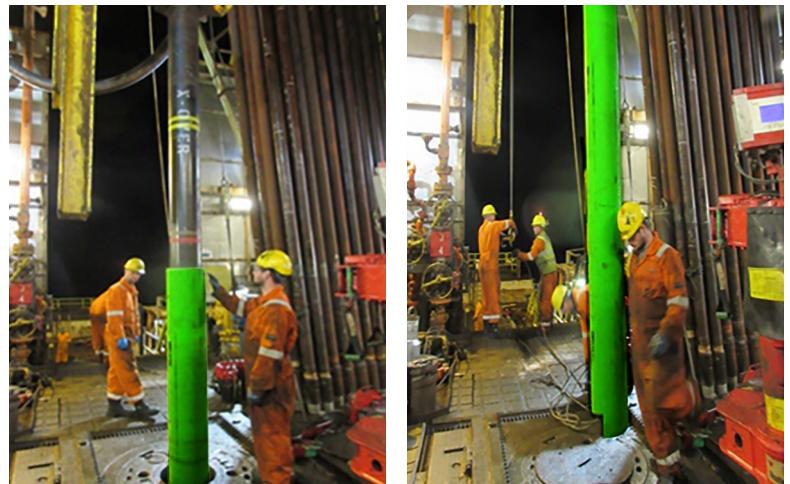
*9 5/8 inch high-pressure casing patch hanging in the derrick ready to run in hole and install.*
