## Use of ProLATCH-N\* Well Abandonment System, Offshore Western Australia, Results in Significant Time Savings to Cut and Pull 20 inch, 36 inch Casings and Wellhead

The successful use of the ProLATCH-N well abandonment system resulted in a 51% reduction in operational cutting time when compared to direct offset wells.

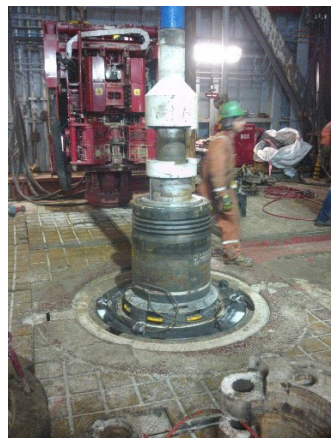
Top Left:  
Thru-rotating spear  
and wellhead at  
rotary table.

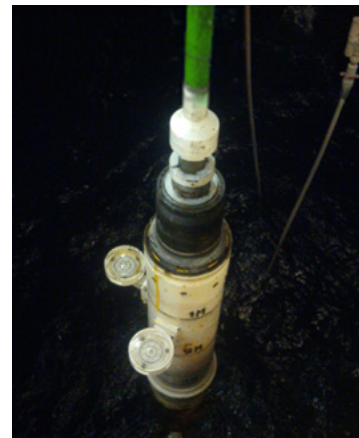
Top Right:  
Wellhead in  
Moonpool

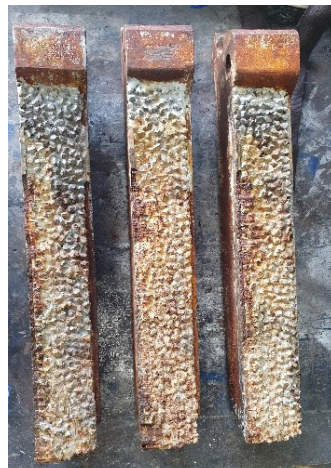
Bottom Left:  
Used 52 in. casing  
cutter knives

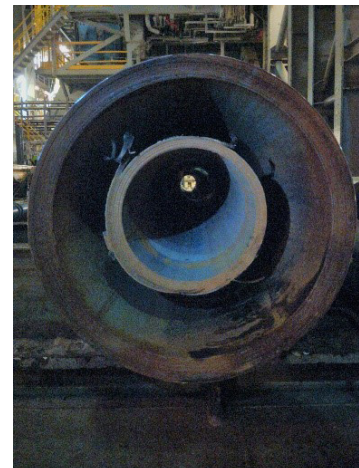
Bottom Right:  
Cut and recovered  
20 in. 213# X-80  
and 36 in. 748#  
X-56 casing at  
surface
