TrackMaster Select System Successfully Deployed, Northern Territory, Australia

The WIS team in Australia mobilized a TrackMaster Select system at short notice to complete a hard formation sidetrack in a single trip.

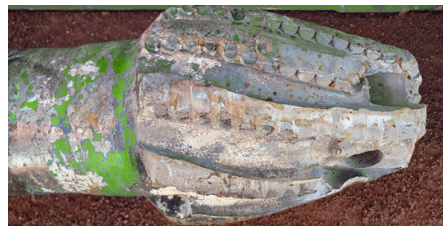
Used Mill Condition

Top right: Lead mill

- Rapid mobilization from the WIS support base to the Northern Territory rig location was completed with on-time delivery.
- The TrackMaster Select was oriented and set, with window milled and rathole drilled in a single trip
- At surface, the tri-mill was within allowable gauge limits, despite the high compressive strength formation characteristics
- The subsequent 8¹/₂ inch directional assembly passed through window without issue, allowing the well to be drilled to TD.

WIS mobilized TrackMaster Select equipment and experienced personnel to conduct an exploration well sidetrack in the Northern Territory, Australia. The system was set in 9⁵/₈ inch P-110 casing at a depth of 1199 m. The formation for the sidetrack was classified as medium-hard with a compressive strength of >13k psi. The system was oriented and hydraulically set at the desired depth. The milling and drilling time was 12 hours in total, for 4.7 m of casing and 3.3 m of formation. After reaching Total Depth (TD), the well was circulated clean, and the milling assembly recovered. The mill was determined to be in gauge and the subsequent directional drilling assembly was deployed and drilled the well to TD. It was notable that the mill gauge, and wear condition remained acceptable after a high compressive strength formation application such as this.

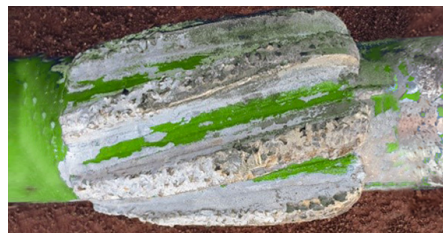
Center: Follow mill

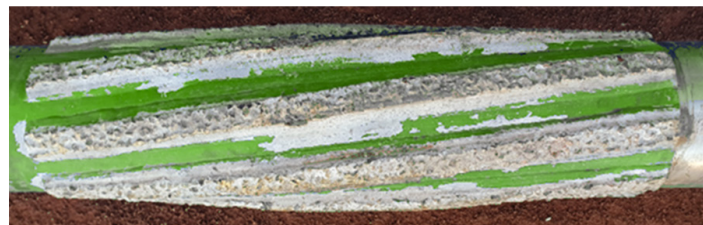
Bottom: Dress mill
