Custom Well Interception Mills Achieve Success in Brazil

Interception Mills, developed and manufactured by Wellbore Integrity Solutions (WIS) in Brazil exceed performance expectations in a five well interception campaign .

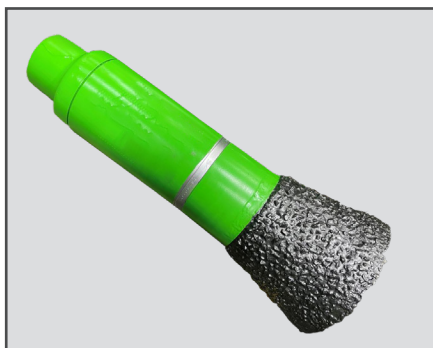
Example Interception Mill

In the planning of a multi-well abandonment campaign, the WIS' DRILCO team in Brazil worked closely with the customer and partner service companies to develop and build a customized, interception mill that would enable access into the intercepted wellbores. The interception window was required in an 8 5/8 inch external casing with 5 1/2 inch and 3 1/2 inch casing and tubing inside it. The Interception Mill was therefore designed to open a window in this complex geometry.

A customized interception mill was developed and provided, that met the technical criteria of each well size, casing configuration and window profile to enable P&A operations.

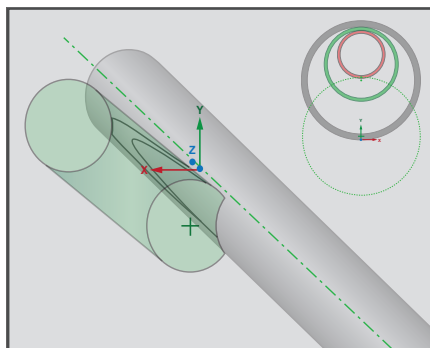
Illustration of Geometry Complexity
