Creative Fishing Solutions Restores Well Production in Kazakhstan

Wellbore Integrity Solutions' (WIS) Red Baron fishing and remedial services successfully completed a complex workover in a valuable, producing well.

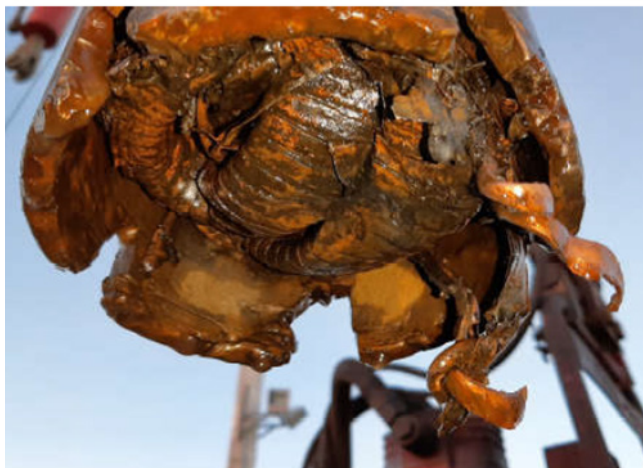
A customized Junk Basket with spring tines effectively recovers the ESP cable.

As part of the solutions provided, a modified Rope Spear and a Custom Junk Basket with spring tines was designed and manufactured at the WIS local base on an urgent basis. These customized solutions were key items that enabled the recovery of 800m of ESP cable. A mechanical backoff with a Left Hand (LH) Die Collar BHA recovered the production tubing and allowed access to the Hydraulic Packer. The Hydraulic Packer was then milled and retrieved.

- A modified Rope Spear and a custom designed Junk Basket was manufactured locally at short notice. These items were important in the recovery of the ESP cable
- A mechanical backoff with a LH Die Collar retrieved the production tubing
- The 7 inch hydraulic packer was subsequently milled and retrieved

- Retrieved 450m of ESP cable with a modified rope spear
- Retrieved 350m of ESP cable with a custom designed and manufactured Junk Basket
- Retrieved 84 joints of production tubing with the LH Die Collar
- Milled and retrieved the 7 inch hydraulic packer
- Completed the project to the customer's satisfaction
