Fishing Operation Results in the Successful Recovery of a High-Value BHA and Restores Wellbore Access

The WIS team in Australia completed a fishing operation that saved significant cost to the customer, including a drilling BHA valued at \$4.8 million.

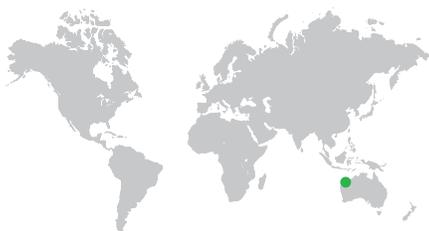
Wellbore Integrity Solutions (WIS), Australia, in cooperation with the customer, successfully retrieved a complex directional assembly.
