Ecuador Achieves Successful Cased Hole Sand Cleanout and Well Stimulation in a Single Run

First use of a 45% inch Sand Bailer and 6 inch Junk Mill to clean sand from a 7 inch casing and perform biocide well stimulation in a single workover run.

*Mark of Wellbore Integrity Solutions. Other company, product, and service names are the properties of their respective owners. Copyright © 2025 Wellbore Integrity Solutions. All rights reserved. WIS-FS-MKT-281_rev1

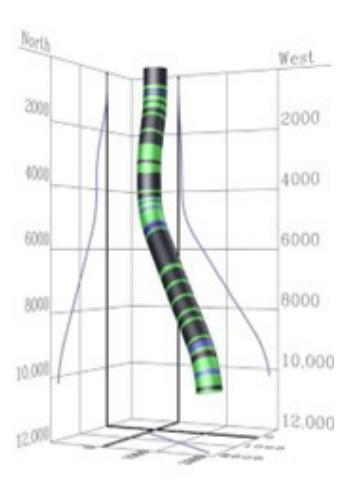
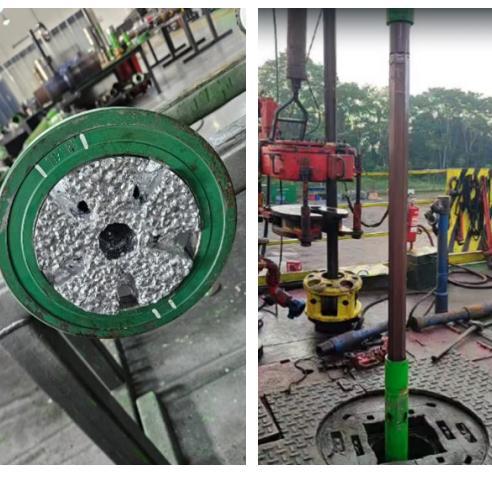
Left: Well trajectory Center: Junk Mill 6 inch OD Full Bore with Gauge Ring Right: Sand Bailer System Mandrel

The Sand Bailer System's competitive advantage over similar local tools lies in its rotary connection, which enables the BHA to rotate, clear obstacles, and retrieve resin and sand from the wellbore. This capability allowed for an integrated approach, saving the customer up to one trip by combining sand clean out and well stimulation. Technology selection and BHA optimization were key customer priorities, and WIS engineering delivered the optimal solution to meet their objectives.

- A 45% inch Sand Bailer with a 15 inch stroke to retrieve material into the chamber.
- A 6 inch OD Junk Mill to remove remaining resin and sand.
