Well Abandonment Technologies Deliver Outstanding Results, Offshore, Western Australia

Successful deployment of Wellbore Integrity Solutions pipe cutter and ProLATCH-N* wellhead recovery systems highlight one-trip efficiencies and the resulting time savings.

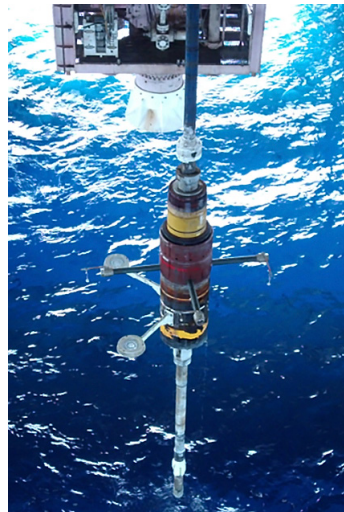
Top Left:
Casing cutter and wellhead in moonpool.

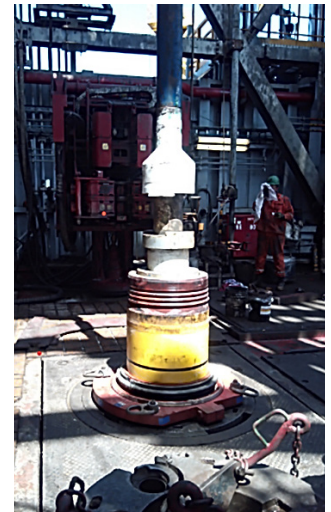
Top Right:
Series 18 spear and wellhead at rotary table.

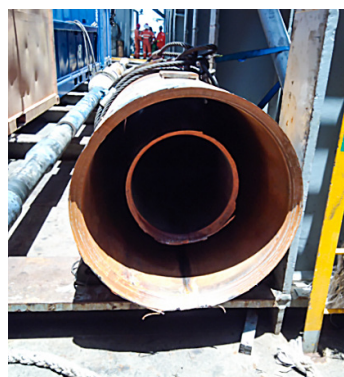
Bottom Left:
Cut and recovered 20 in. 213# X-80 x 36 in. 748# X-56 casing at surface.

- A heavy wall 9 $\frac{7}{8}$ inch casing string was tension cut in 4 minutes and successfully recovered.
- A ProLATCH-N wellhead recovery system, with a heavy-duty pipe cutter, dressed with the latest milling technology, was deployed to cut 20 inches and 36 casings and retrieve the FMC UWD-15-RL wellhead assembly in a single trip. Both casings were cut in 2 hours, 15 minutes, and the wellhead assembly recovered as planned. The time to cut both casings was determined to be significantly faster than offset examples.

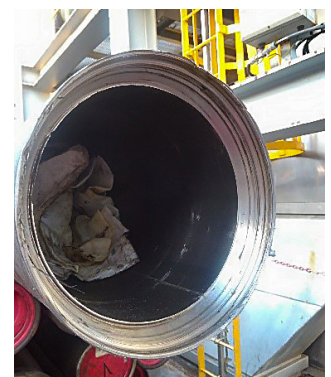
Bottom Right:
Cut 9 $\frac{7}{8}$ in. casing at the surface.
