RED | BARON

**PERFORMANCE
BULLETIN
PORTFOLIO**

Successful Gator Perforator Performance in a Gulf of Thailand Well Abandonment Campaign

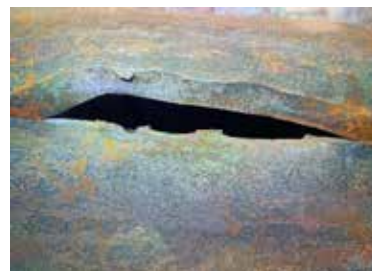
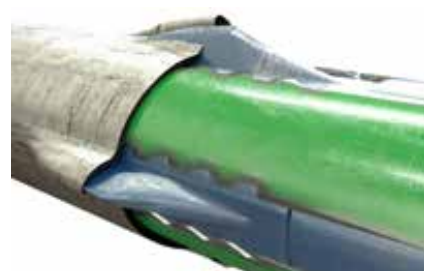
Large TFA Perforations from the Gator Perforator

The 570PPT Gator Perforator was chosen as the ideal solution. When activated, four symmetrical, large TFA perforations are created, and the depth control feature ensures no damage to the outer casing.

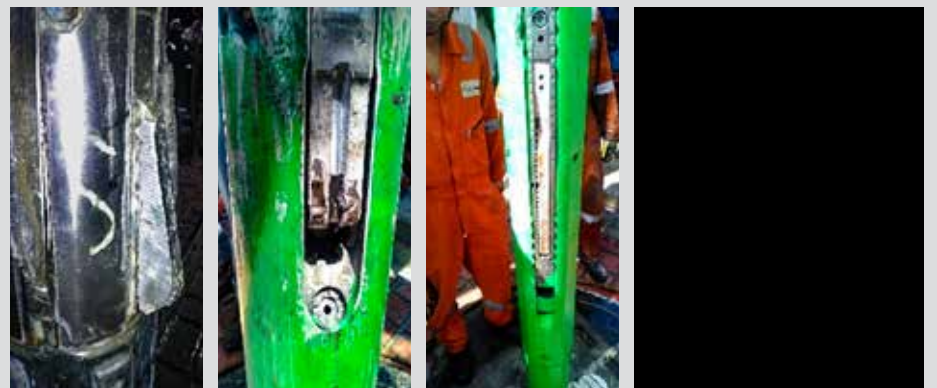
Left: Section Mill 5500 Series

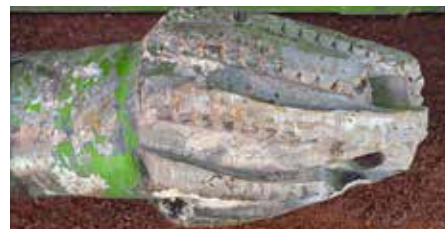
Used Mill Condition

Top right: Lead mill

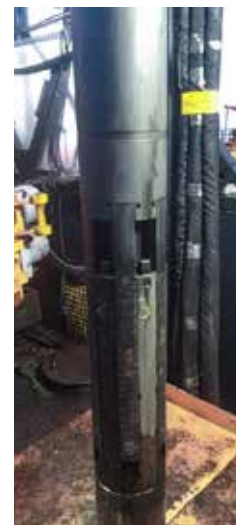
ERS, post run condition

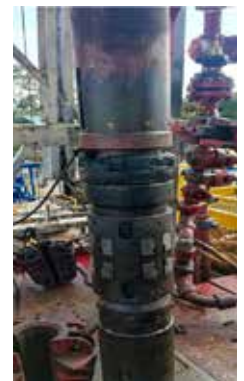
Figure 4: Successful recovery of lower Quantum Packer.

A completion recovery, by the WIS team in Ecuador, developed into a more complex operation due to the heavily corroded condition of the completion string and packers. The completion string comprised of 3½ inch tubing, which was completely corroded in multiple areas (Figure 1&2), and two Quantum Hydraulic Packers, in both the 9⅝ inch and 7 inch casings (Figures 3&4).

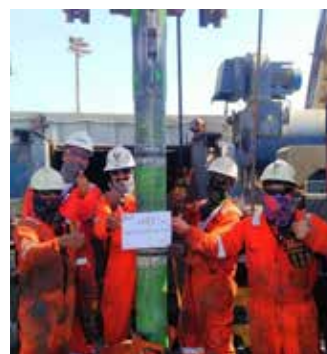
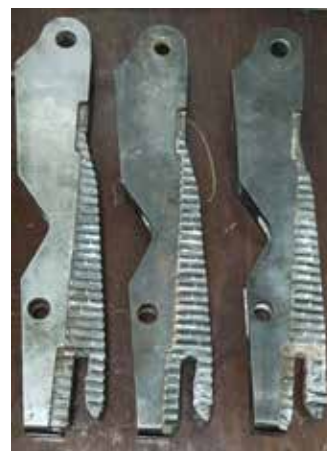
Section Milling Efficiency Results

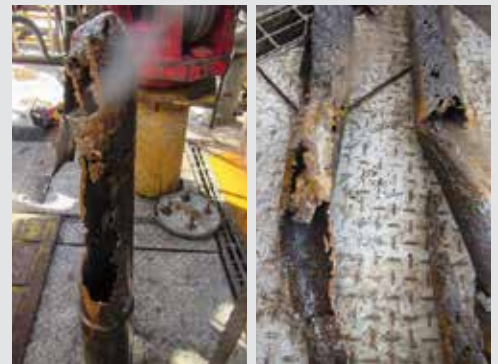
Figure 1: Recovered corroded tubing.

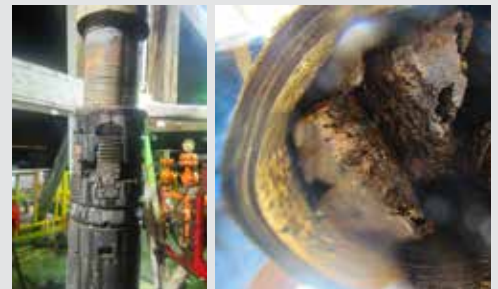
Figure 2: Recovered HS packer.

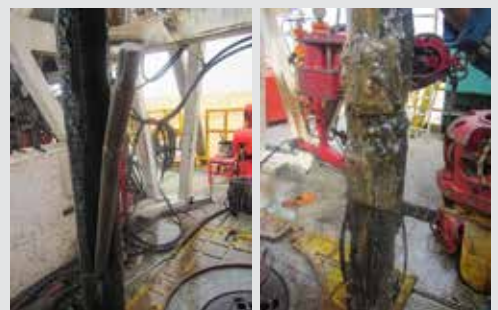
Figure 4: Recovered wireline tools previously lost in hole without any records.
