**PROSCAN
WELLSITE
INSPECTION
SERVICE**

Vertical
Electromagnetic
Wellsite Inspection
Service for
Production Tubing

WIS-BR-MKT-015_Rev4

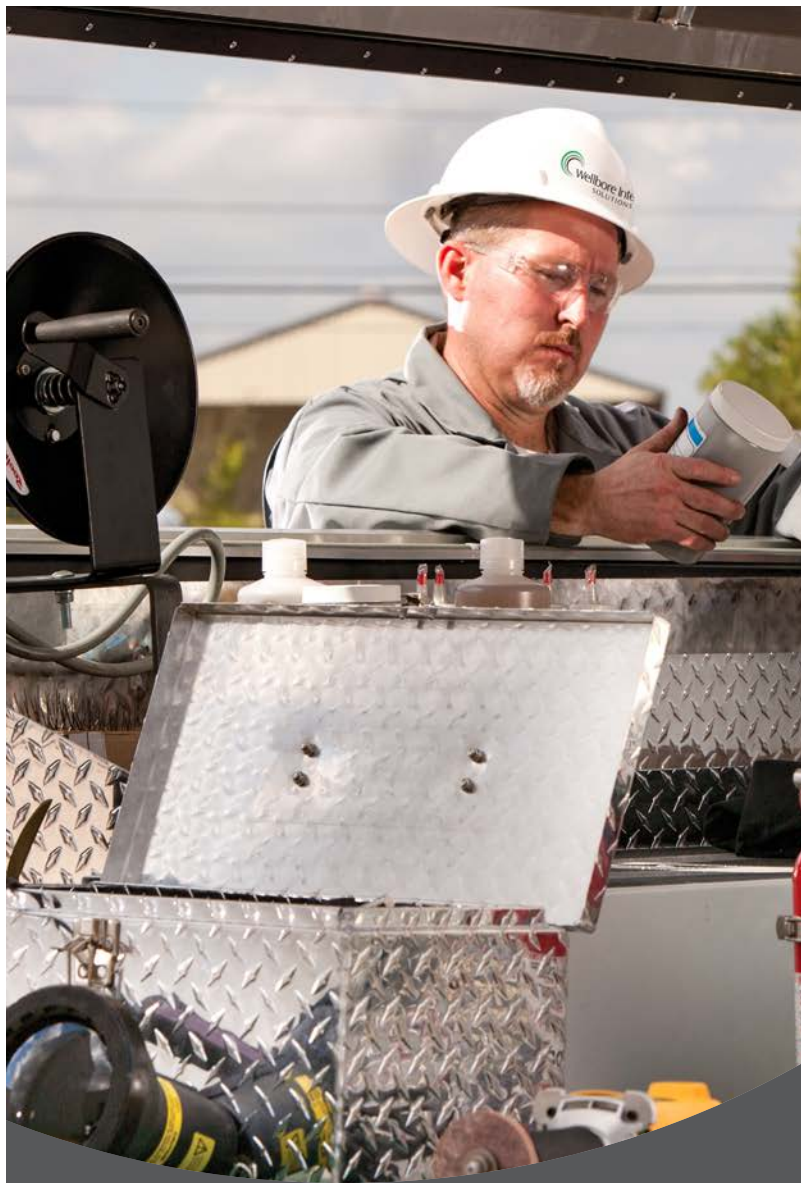
Head Inspection Box

- Localized wall loss (for pitting)
- Thru-wall splits (open or closed)
- Rodwear loss (body wall monitor)
- Thru-wall hole detection (dedicated channel)

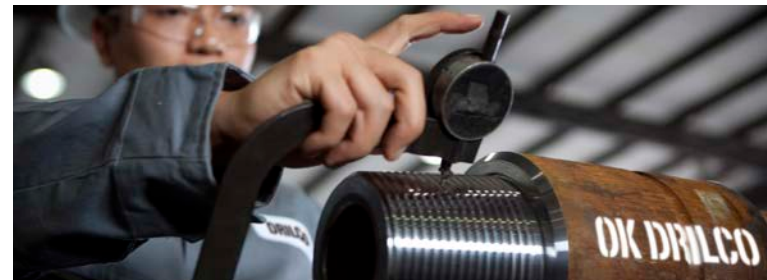
Thru-wall Longitudinal Split

1. Longitudinal split present
2. Corrosive pitting
3. Erosion and isolated rod wear
